RGS Goose No. 5

Rear Axle of the Power Truck

1/2/2018 Rear Power Axle Removal

1/5/2018 Rear Power Axle Disassembly

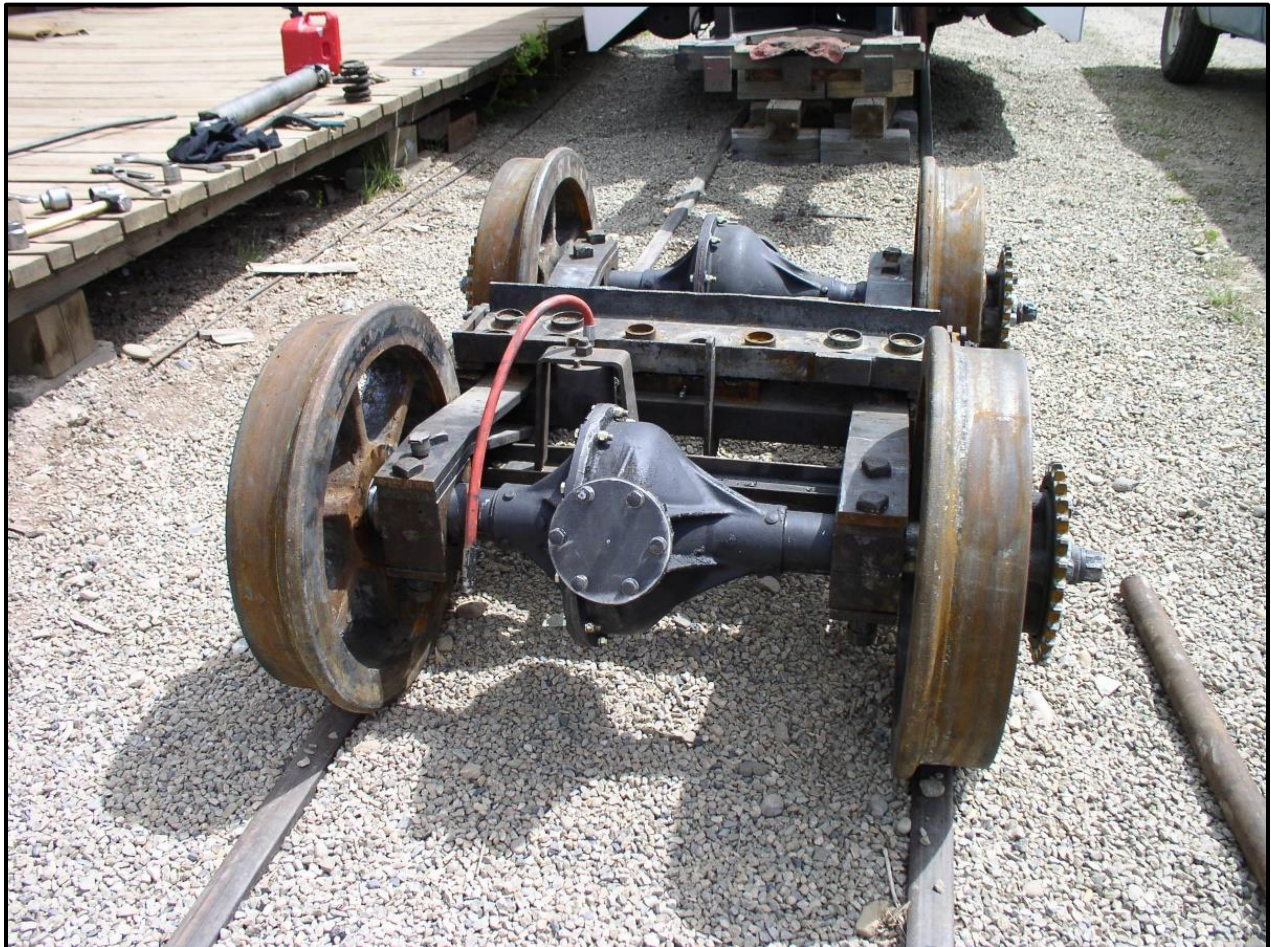
Photo taken in 2009 during reassembly of RGS Goose No.5 after power truck rebuild by Skansa Construction.

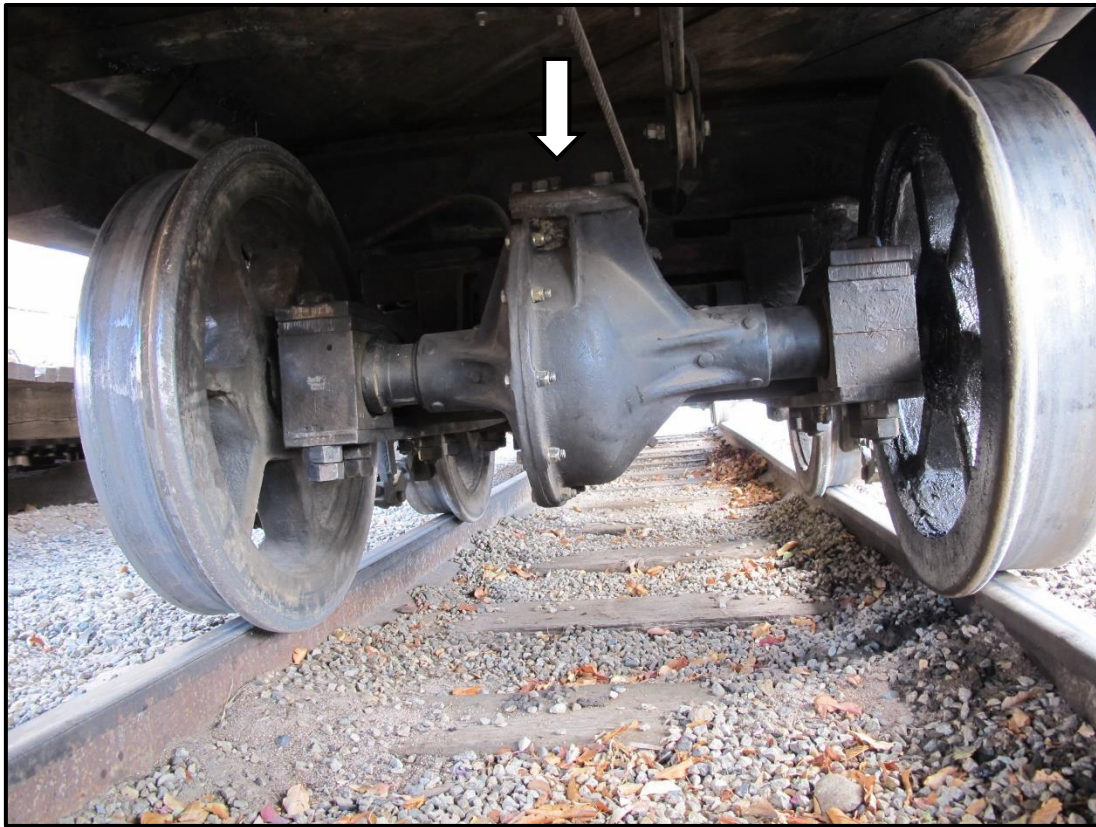
Here's the current orientation of the rear axle assembly. (Photo taken December 2017)

Note that the rear axle assembly has rotated almost 90 degrees to where the drive shaft plate is now on the top. The fill/drain ports are still not aligned correctly in this orientation either. The fill port is near the top of the pumpkin, making it possible to overfill with gear oil. The hand brake cable also binds on the side of the axle housing.

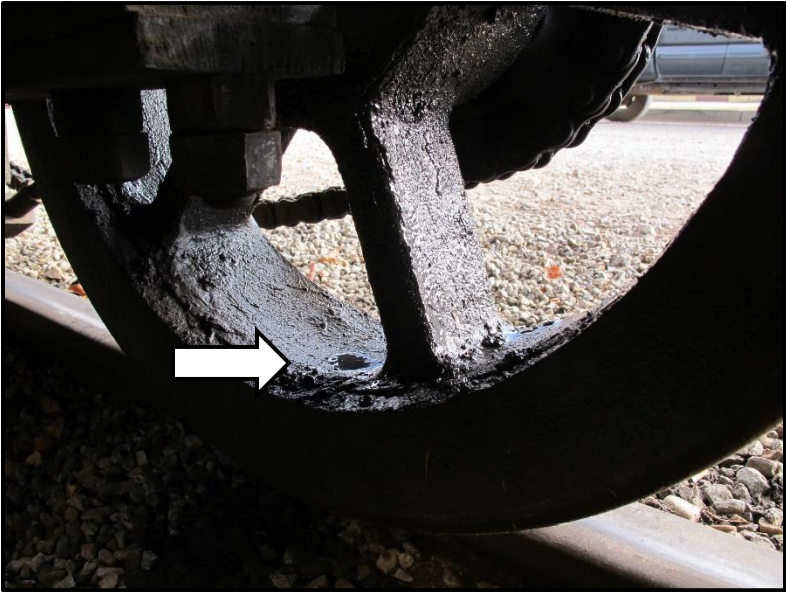
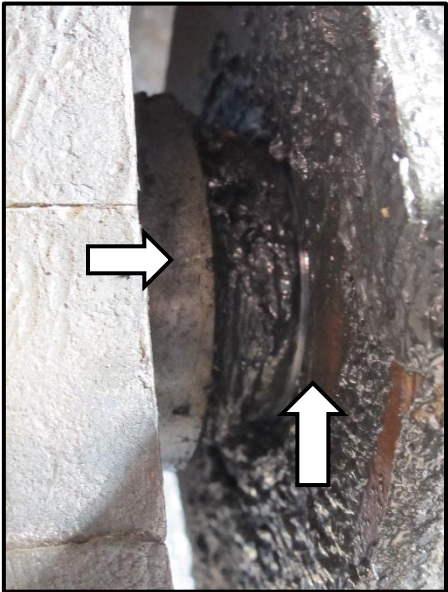
Here's a photo of the inside of the rear right side wheel. (Photo taken December 2017). Notice the pool of oil collected on the inside rim of the wheel. The other picture is taken of the axle housing between the wheel and brass blocks. Note the collar and the cage bearing.

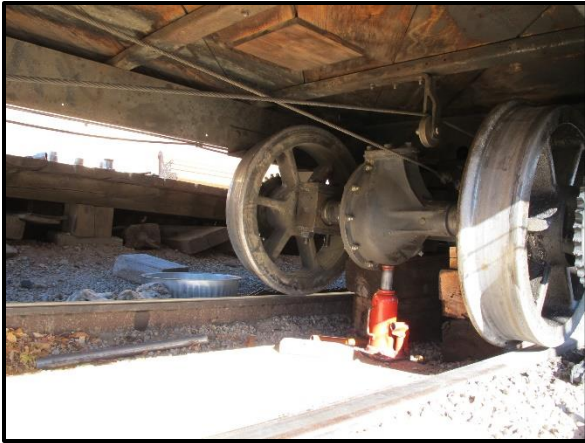
- Wheels spin freely and independent of each other with chain off and rear differential housing jacked.

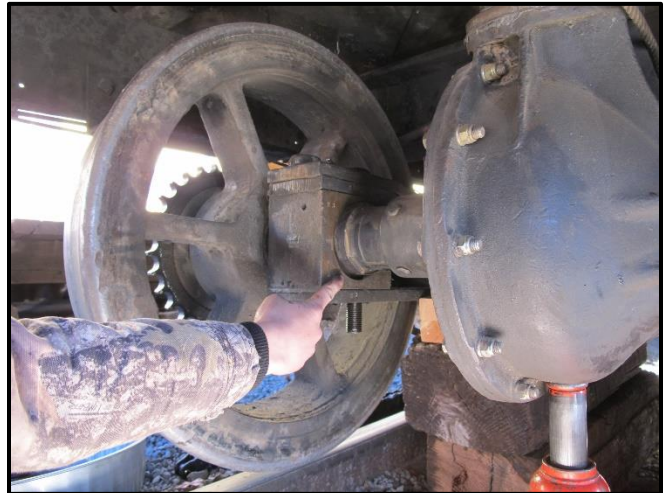
- Note the oversized and/or wear on the brass bearing on the left side (non-leaking).
Differential housing was clamped firmly to truck assembly on only the right side. Left side was deliberately loose to allow power truck to flex.

The one set of brass blocks that provide flex to the power truck on the back axle will be machined to .005 tolerance and reused. The Zerk fitting on top will be reinstalled and used. The brass blocks on the front differential will also be inspected.

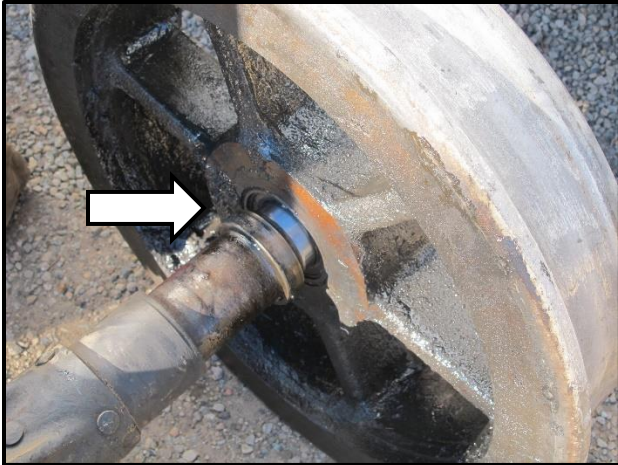
Note the shiny part on the differential housing next to the wheel.

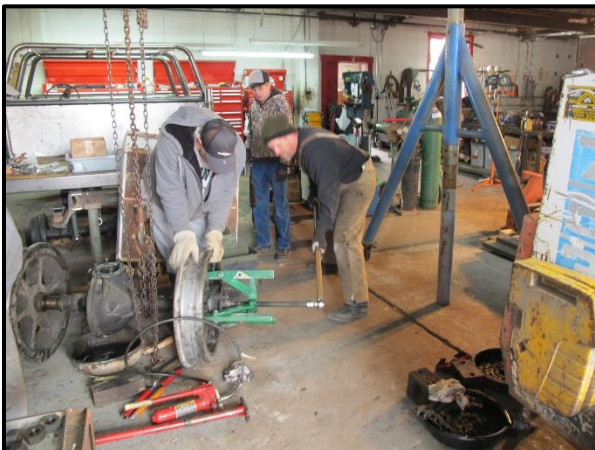
Here's the wheel puller in action.

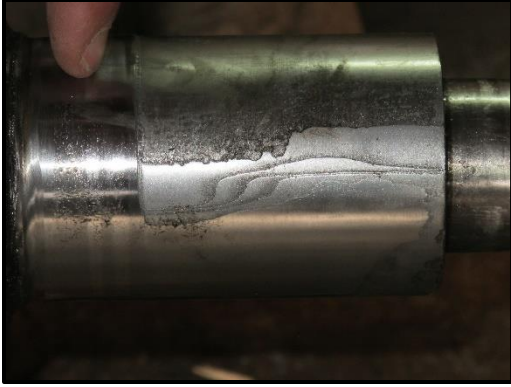
Degradation of the hard chrome on the axle.

"The cage bearing became dry due to lack of grease from the Zerk fitting near the axle nut. The cage bearing heated up and caused a partial failure of the hard chrome and the adjoining outer seal on the differential housing."

*From what I see in the pictures the failure was classic brinelling. The chrome plating separated from the housing due to the high concentrated loads imposed by the roller bearing. The pitted chrome and irregular surfaces created friction. Chrome itself is capable of extremely high temperatures. I have used it in turbine engines in locations where temps are 1200F.
What is the condition of the bearing itself? Is it reusable? Is there a part number on it?*

I don't think the bearing ever ran out of grease. The failure of the chrome plating resulted in the axle losing center line control resulting in the seal not capable of performing its job.

RGS used the chrome to get a hard surface for the roller bearing to ride on. We just need to plan to have this plating removed and replaced on a scheduled basis. The housings should be sent out for a "Grind/plate/grind". Please measure the diameter of the chrome surfaces of the replacement housings. This is a standard process used for repairing shafts, including crankshafts in automotive engines. Arizona Hard Chrome in Phoenix is a place I know of (azhardchrome.com).

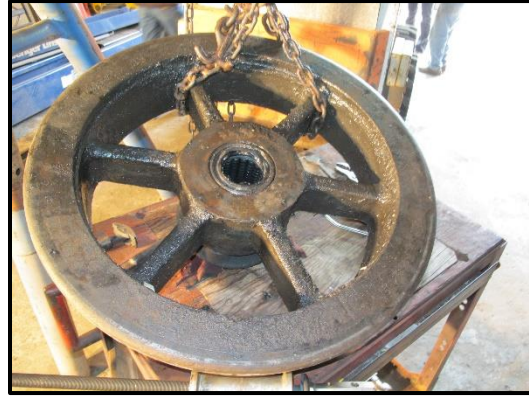
The inside of wheel with cage bearing.

Mike the Machinist's recommendation on how to grease the cage bearing is to pump grease through the Zerk 5-6 times until it oozes out on the other side, rotate the wheel 1/4 to 1/3 turn and re-grease again and again. You should not be overly fearful of blowing a seal because of over-greasing.

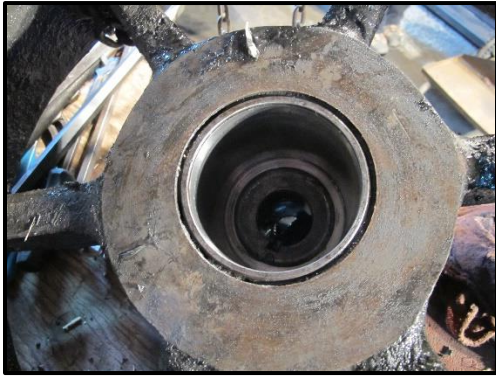
The inside of wheel with cage bearing removed. (Thanks to Nicholas, the town bicycle mechanic, who spotted the retaining ring on the seal.)

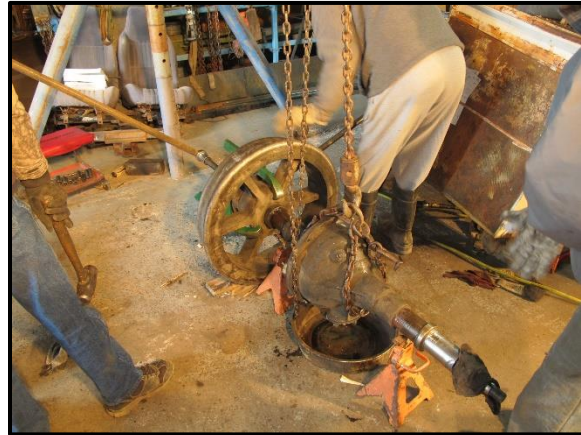
The other wheel being pulled.

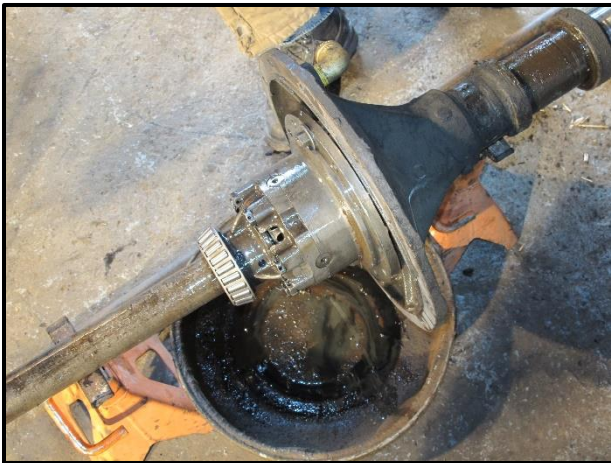
The interior tapered bearing.

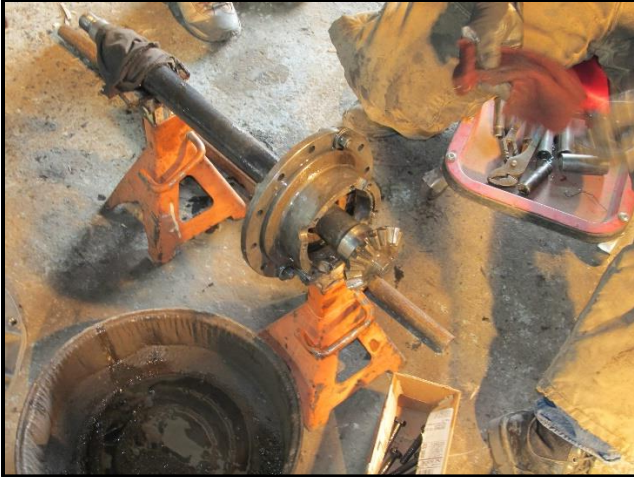
The internal gear that is part of the spider gear.

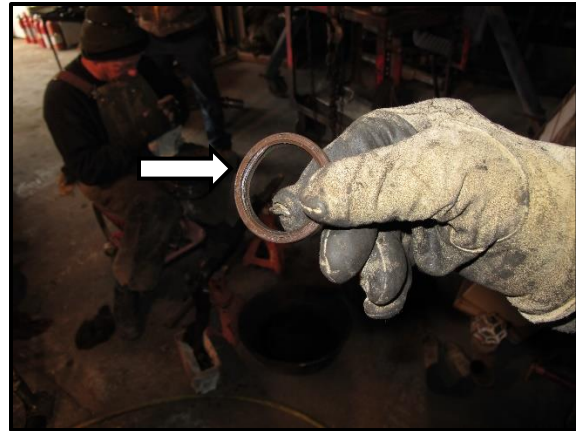
The failed outer seal of the differential housing.

Lew Matis went to Cortez and ordered six cage bearing seals and six outer differential housing seals (2 to be used and 4 spares) from NAPA. All the seals had legible serial numbers. Lew also ordered 3 paper seals to mate the banjo together via the internet (Thanks John Randall). We were informed that the proper terminology for the bulbous of the differential is a banjo and not a pumpkin.
