RGS Goose No. 5

Rear Axle of the Power Truck

1/2/2018 Rear Power Axle Removal

1/5/2018 Rear Power Axle Disassembly

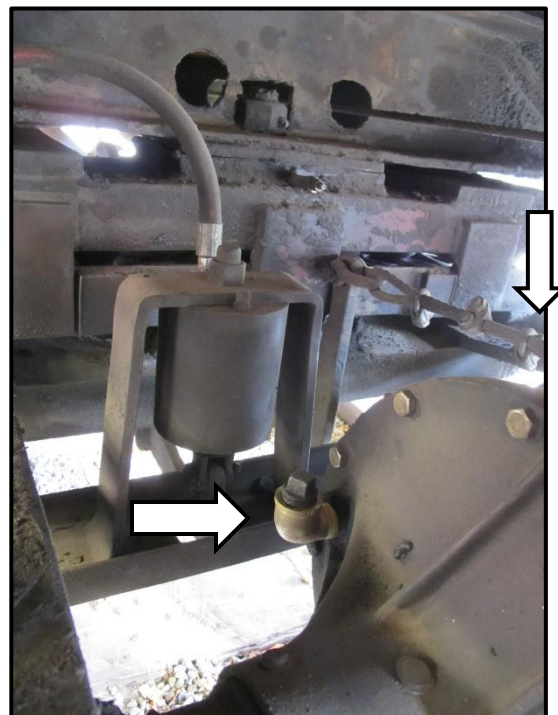
Note that the rear axle assembly has rotated almost 90 degrees to where the drive shaft plate is now on the top. The fill/drain ports are still not aligned correctly in this orientation either. The fill port is near the top of the pumpkin, making it possible to overfill with gear oil. The hand brake cable also binds on the side of the axle housing.

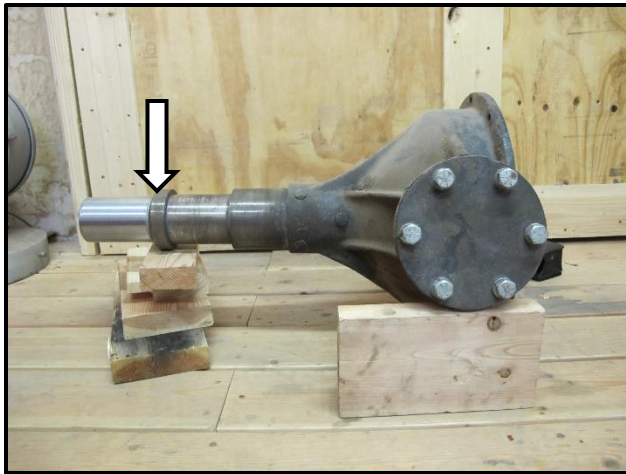
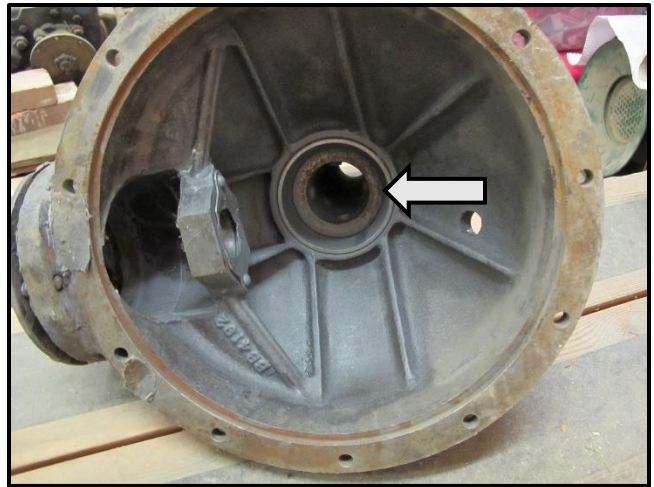
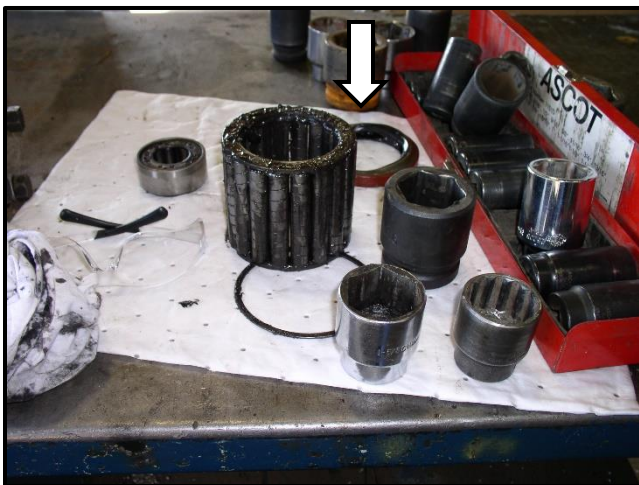
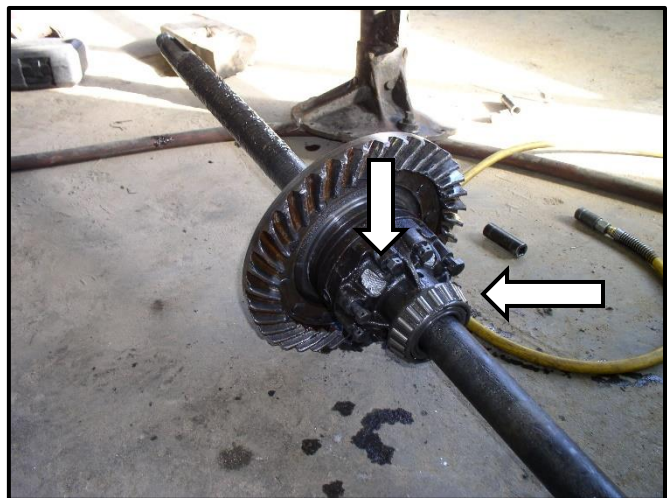
Note the collar on the axle housing, the bearing race, the cage bearing and seal somewhat hidden by the socket. Also note the tapered roller bearing and the "lead" that is locking the differential.

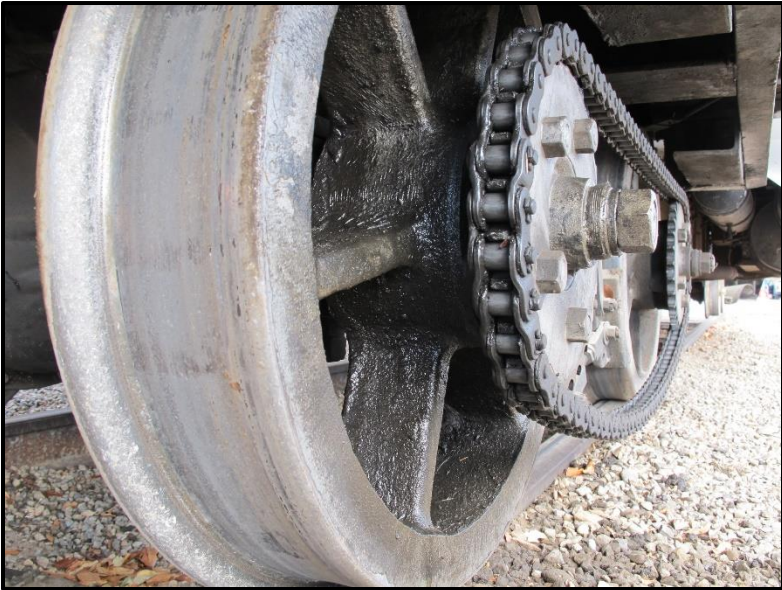
Here's a photo of the inside of the rear right side wheel. (Photo taken December 2017). Notice the pool of oil collected on the inside rim of the wheel. The other picture is taken of the axle housing between the wheel and brass blocks. Note the collar and the cage bearing.

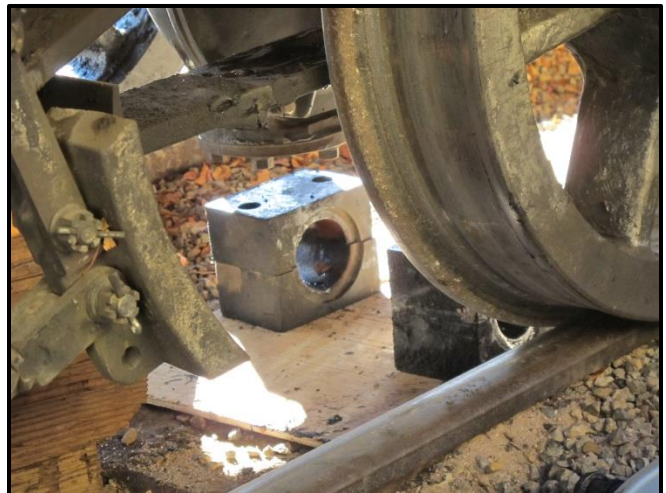
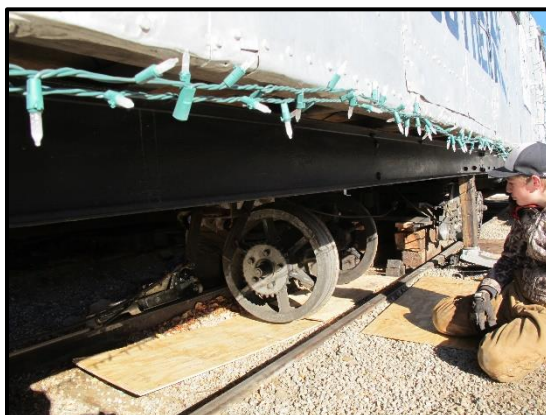
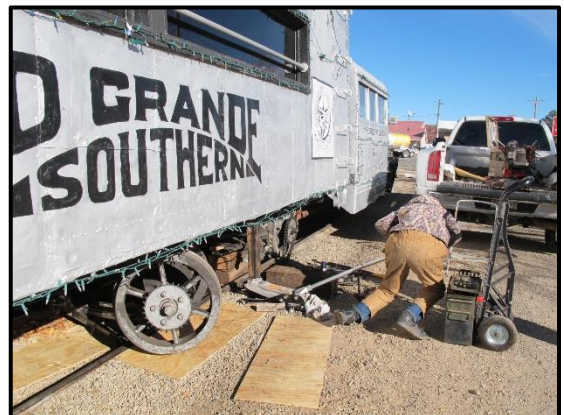
- Note the oversized and/or wear on the brass bearing on the left side (non-leaking).
Differential housing was clamped firmly to truck assembly on only the right side. Left side was deliberately loose to allow power truck to flex.

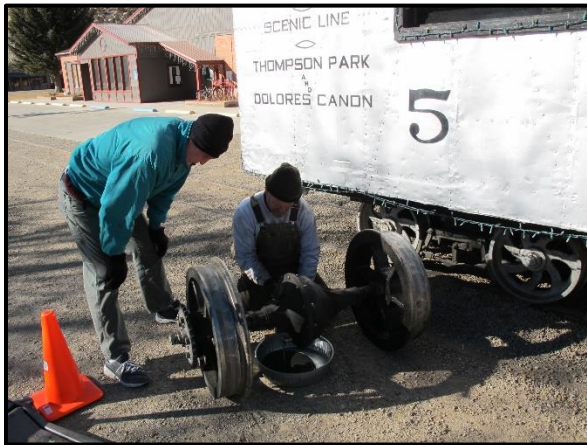
Note the shiny part on the differential housing next to the wheel.

With rear differential axle being dis-assembled, the chains will be soaked and cleaned. Wheels will not be turned. Like automobile tires, it is thought that power wheels should be turned as sets of four.

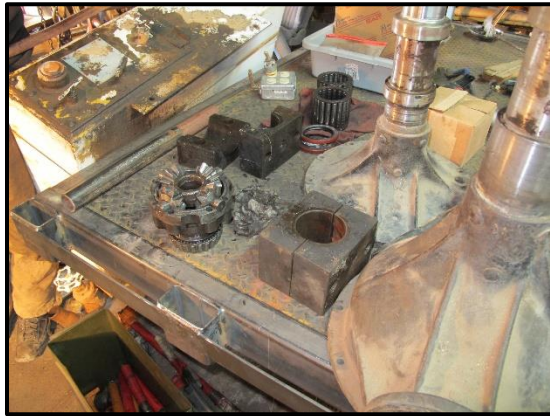
The failed outer seal of the differential housing.

Here's the **consensus scenario** of those present during disassembly of what caused the failure of the hard chrome and the subsequent failure of the outer differential housing seal.....

"The cage bearing became dry due to lack of grease from the Zerk fitting near the axle nut. The cage bearing heated up and caused a partial failure of the hard chrome and the adjoining outer seal on the differential housing."

*From what I see in the pictures the failure was classic brinelling. The chrome plating separated from the housing due to the high concentrated loads imposed by the roller bearing. The pitted chrome and irregular surfaces created friction. Chrome itself is capable of extremely high temperatures. I have used it in turbine engines in locations where temps are 1200F.
What is the condition of the bearing itself? Is it reusable? Is there a part number on it?*

I don't think the bearing ever ran out of grease. The failure of the chrome plating resulted in the axle losing center line control resulting in the seal not capable of performing its job.

Mike the Machinist's recommendation on how to grease the cage bearing is to pump grease through the Zerk 5-6 times until it oozes out on the other side, rotate the wheel 1/4 to 1/3 turn and re-grease again and again. You should not be overly fearful of blowing a seal because of over-greasing.

RGS used the chrome to get a hard surface for the roller bearing to ride on. We just need to plan to have this plating removed and replaced on a scheduled basis. The housings should be sent out for a "Grind/plate/grind". Please measure the diameter of the chrome surfaces of the replacement housings. This is a standard process used for repairing shafts, including crankshafts in automotive engines. Arizona Hard Chrome in Phoenix is a place I know of (azhardchrome.com).
